METAL DUSTING OF INLET TUBE MADE OF ALLOY 800

IVAN HRIVŇÁK^{1*}, LUBOMÍR ČAPLOVIČ¹, GEJZA BAKAY²,
AUREL BITTER²

²*DUSLO, a.s., R&D, Šaľa, Slovak Republic*

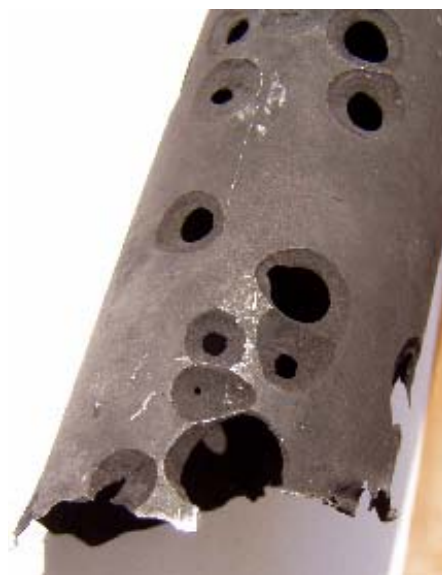
After several years of operation the inlet tubes were checked and analysed. The appearance of the end of the investigated tube is shown in Fig. 2. The inside diameter of the tube is 28 mm, outer diameter 33 mm, its total length approx.

Fig. 2. A general view on the inlet tube made of Alloy 800.

270 mm. The front part of the tube, in the length 65 mm, was inside the fireclay and was not damaged by dusting phenomenon probably due to its higher temperature. The inlet tube was fixed into the tube sheet by a fixing ring. As seen from Fig. 2, the end of inlet tube was severely thinned and several pits and holes were observed in this region. The inner, as well as the outer surface of the tube were heavily contaminated by dust. The morphology of dust was analysed by scanning electron microscope (SEM) as well as by transmission electron microscope (TEM). A two-step celluloid-carbon replica was prepared from tube surface contaminants. In the first step one side of the celluloid film (Bioden) was softened by acetone and slightly pressed into the tube surface. After several minutes the celluloid strip was taken off the surface. A lot of contaminants covered this surface. In the second step a thin carbon film was evaporated into the active surface of celluloid strip in high vacuum, and subsequently the celluloid strip was dissolved in acetone. It is a usual procedure in transmission electron microscopy. Figures 3a,b show the morphology of contaminant dust. In Fig. 3a a SEM image shows many discrete particles on the surface of the tube. In Fig. 3b (TEM) several black extracted particles are parts of metal dust in the form of oxides and carbides but in between there is a very fine colloid dust of carbon. The detail of two carbon morphologies is shown in Fig. 4.

Equivalent value of this summation for Alloy 800 is about 240, while that for Alloy 602 CA about 600. This means that Alloy 602 CA is more resistant to dusting as Alloy 800. From that it follows that one of possible solutions is to replace the type of alloy. Probably due to local inhomogeneities (large grain size, TiN inclusions) it is difficult to obtain a dense and protective scale in Alloy 800.

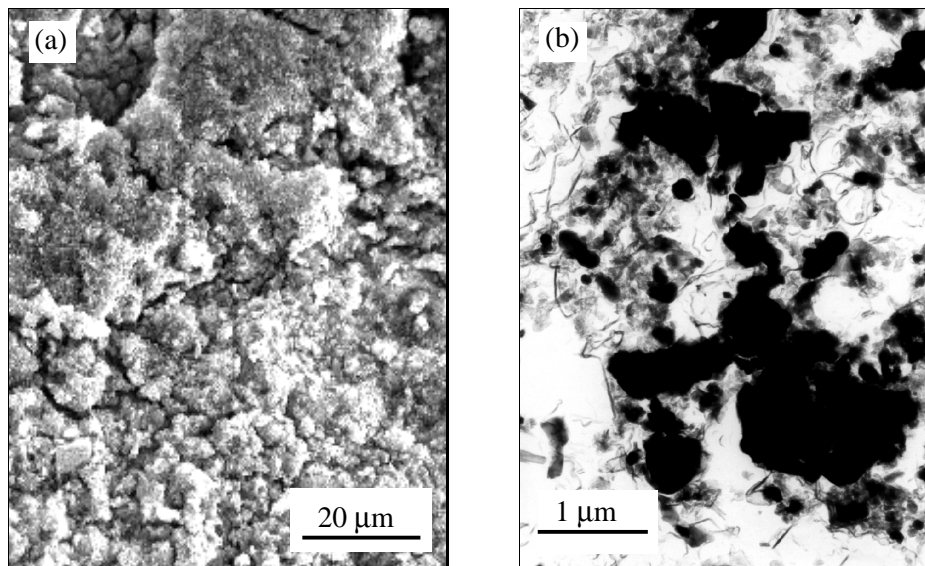
Fig. 3. Morphology of tube surface contaminants: (a) SEM, (b) TEM, two steps celluloid-carbon replica.

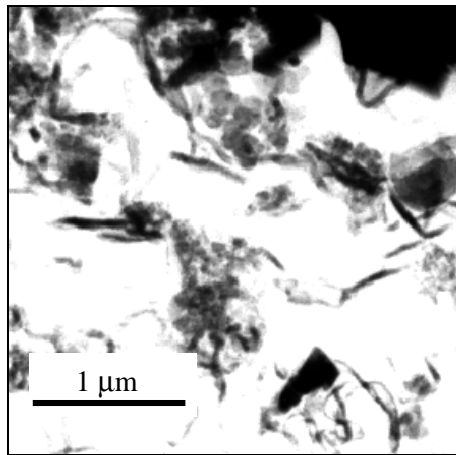
Except of fine amorphous carbon dust also fine rods of carbon were identified. By electron diffraction we have identified in the extracted dust also oxides of chromium, silicon, aluminium and, as to be expected, chromium carbides, but the diffraction rings from very fine (“background”) particles were of very diffuse nature, the same as those of the carbon replica itself. By EDX analyses in TEM we have identified the occurrence of elements from alloy itself and also some Si, Al and Mg, which could come from the particles of fireclay. This means that except of carbon from the chemical reaction between methane and steam, the flowing gas is also entrapping particles from fireclay. These hard particles could then contribute to some abrasion of the tubes’ surface, which was covered by chromium oxide film.

Fig. 4. Very fine globular and rod-like particles of carbon. TEM.

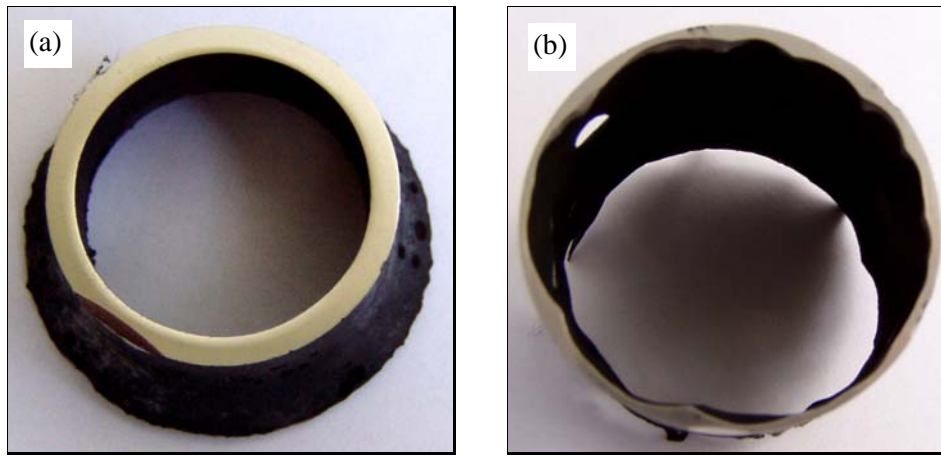
Fig. 5. Polished and etched cross-sections of the inlet tube at the front, non-damaged part (a) and at the end part damaged by dusting (b).

To analyse the microstructural features, we have prepared several samples from tube cross section, from the entry part of the tube, which was not damaged by dusting process, and from near the damaged end of the tube. The appearance of two polished and etched surfaces is shown in Figs. 5a,b. The microstructure of the tube entry part, which was not damaged, consists of polygonal austenite grains and second phase particles, which were oxides and carbides in nature. In between, some porosity of tube was also detected. Figure 6 shows the microstructure of that part of inlet tube. The cross section appearance in the damaged (thinned) part of the tube is in Fig. 7 (after electrolytic polishing) and its microstructure in Fig. 8. Grain and subgrain boundaries, and slip planes were etched preferentially. At these sites the occurrence of chromium carbides was detected. More detail of these sites is given in Fig. 9 (SEM) and the appearance of carbides in Fig. 10. Comparing to the entry part of the inlet tube, which was not damaged by dusting, we can conclude that the microstructure of the tube in the dusted area was very different. Grain boundaries and subgrain boundaries, as well as the slip planes, became sensitive to etching. The density of second-phase particles was much higher. They were composed of chromium carbides namely. At these etched sites also two kinds of carbon particles were detected. Very fine rods were of crystal nature while fine globular shapes were giving a very diffuse diffraction rings corresponding to amorphous phase.

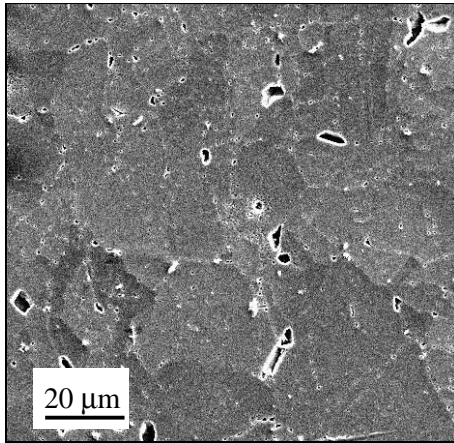
Fig. 6. Microstructure of the front part of tube, not damaged by dusting. SEM.

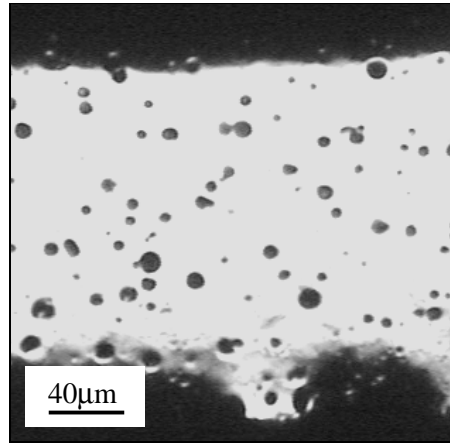
Fig. 7. Unetched metallographic specimen of the cross-section in the damaged part of the tube. Notice etch pits in the cross-section after electrolytic polishing.

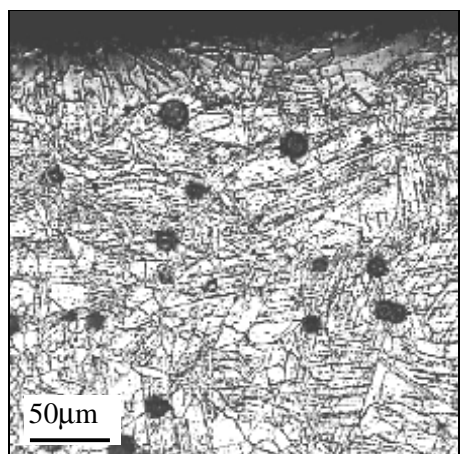
Fig. 8. Microstructure of tube cross-section in the area of dusting attack.

Concerning the microstructural features it was found (Fig. 8) that diffusion of carbon and subsequent carbides formation is – to some extent – leading to

fragmentation of an alloy and easier loss of material. The surface of pit (Fig. 11) is not very much dimpled, it is rather smooth, which prefers the view for nanoscale loss of material.

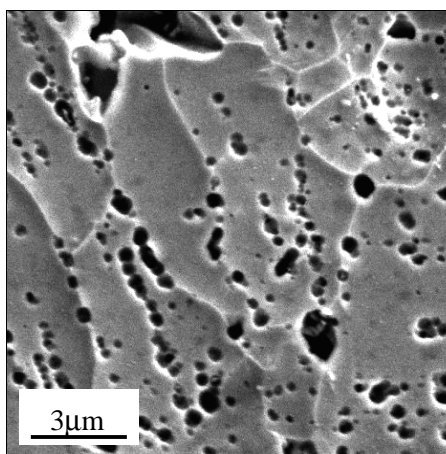
Fig. 9. Microstructure at higher magnification. SEM.

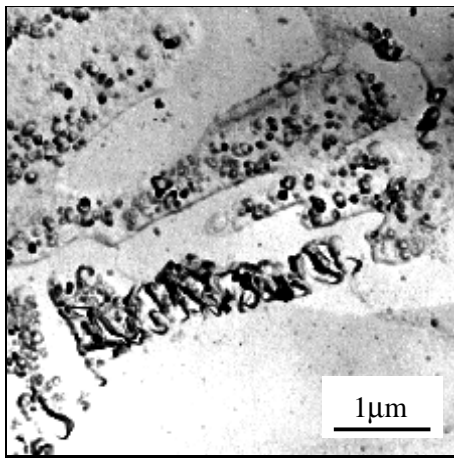
Fig. 10. Second-phase particles in the damaged part of the tube. TEM.

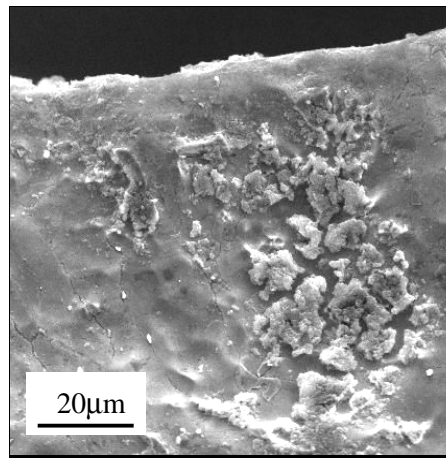
We have also analysed the surfaces of pits and holes by SEM and TEM. Figure 11 shows the edge of corrosion pit after electrolytic polishing. Several contaminants (oxides) are still present. One of them, extracted into replica, is in Fig. 12. It was identified as Cr_2O_3 by electron diffraction. Except of oxides also very fine carbon

Fig. 11. An edge of the dusting hole after electrolytic polishing. SEM.

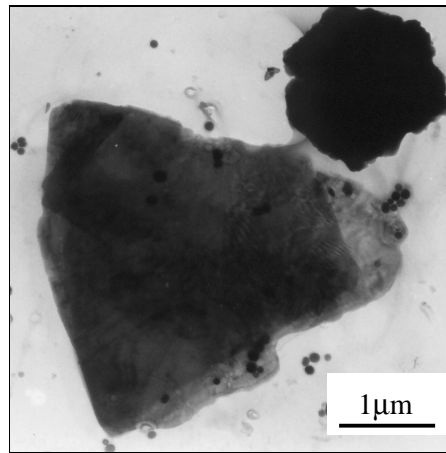
Fig. 12. Extracted Cr_2O_3 particles from Fig. 11. TEM.

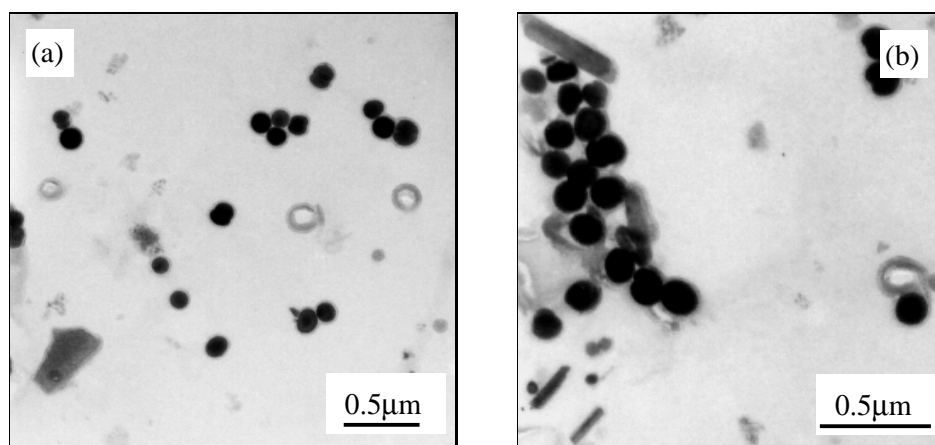
particles were found on pit surfaces. They were again of two kinds: globular, as seen in Figs. 13a,b, and also very fine rod-like ones.

Fig. 13. Very fine globular (a) and rod-like (b) carbon particles extracted from the metallographic specimen in dusting region. TEM.
