Microstructure characteristics near the interface of vacuum brazing of Al/Cr18-Ni8 stainless steel

Abstract

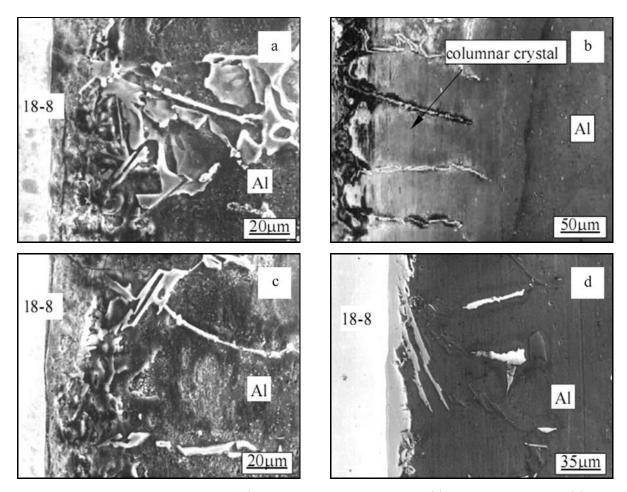
Microstructure of Al/Cr18-Ni8 vacuum brazing joint observed by SEM is shown in Fig. 2a–d. There was no porosity and crack near the brazing interface. The obvious microstructures of columnar crystal can be observed. The columnar crystals grow and stretch from Al side into the brazing metal. The morphology

Fig. 2. Microstructure near the interface of Al/Cr18-Ni8 vacuum brazing joint: (a) brazing metal, 200×, (b) columnar crystal, (c) dendrite crystal, 500×, (d) primary crystal Si, 300×.

of the Al matrix close to the brazing metal is shown in Fig. 2b. The position of the microstructure is parallel in relation to the interface. There are new phases in the surface of the Al matrix.

The dendrites in the brazing interface can be observed (Fig. 2c). The composition measured by the energy dispersive X-ray (EDX) analysis indicated that the bulk and white crystals in Fig. 2d were the primary crystal Si, the fine and white strip crystals were the eutectic Si, and the black matrix was α -Al(Si) phase. At 577 °C, the largest solubility of the Si in α -Al(Si) phase is 1.65 % [7]. In the center of the brazing metal, the state of the brazing filler metal was Al-Si eutectic, and the α -Al(Si) phase can be also observed in the brazing interface. During the vacuum brazing α -Al phase would be firstly separated from the brazing interface, and then separated from the primary crystal Si and the eutectic Si. The α -Al(Si) phase is favorable for the microstructure performance of the Al/Cr18-Ni8 brazing joint.

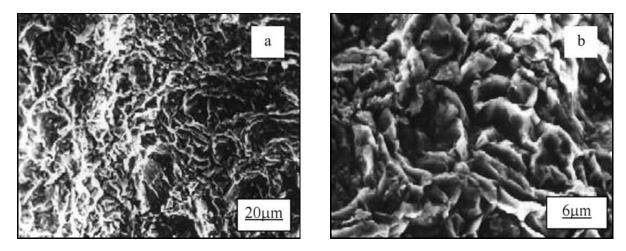
Fig. 4. Fracture morphology of the brazing interface of Al/Cr18-Ni8 stainless steel (SEM): (a) fracture morphology, $500 \times$, (b) local toughness zone, $1500 \times$.

The obvious fracture morphology of the cleavage and toughness can be observed (Fig. 4a) by means of the JXA-840 scanning electron microscope (SEM). The fracture morphology of the brazing metal mainly consists of coarse and gray fiber-shape fracture. The inter-atomic bond between the brazing filler metal and the matrix was destroyed and produced the transgranular fracture. The cleavage and second-fracture would be also produced together, but the second--fracture was quite small. The mixed fracture of the cleavage and toughness can be observed, where the proportion of the toughness fracture was quite large. The fracture morphology consisted of dimple, observed by means of SEM (Fig. 4b). There were the impurity and the second-phase particles in the center of dimple. The dimple was produced due to the difference of ductility and toughness of the second-phase particle and the matrix. With the increasing of ductility deformation and the dimple, the gather and joining of the micro-hole produced the fracture.

There were different mechanical bond zone and

freedom surface in the fracture of brazing joint. The dimension of the mechanical bond zone was small. The metal of two sides was combined closely and formed the metallurgical bond. The dominant feature of the brazing interface fracture was the mechanical bond and the freedom surface. The test results indicated that the fracture morphology was mainly the mixed fracture of the toughness fracture with a little cleavage, and had certain toughness. It is favorable for the performance of the Al/Cr18-Ni8 brazing joint.
