# Exfoliation corrosion behaviour of friction stir welded AA7136-T76 extrusions

## Abstract

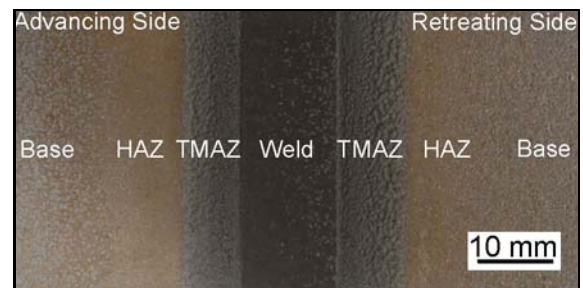
Fig. 9. Exfoliation corrosion test results.

cing sides are areas of significant exfoliation corrosion (rating of EC/ED). The width of the region on the retreating side is greater than that on the advancing side, approximately 11.5 mm on the retreating side and 8.5 mm on the advancing side. Also within each corroded area, two bands are observed as the level of corrosion decreases from the TMAZ/HAZ interface toward a more corrosion-resistant area deeper into the HAZ. Outside of these corroded areas, regions of little to no exfoliation corrosion appear (rating of EA) before giving way to the baseline material, which carries an exfoliation rating of EB. These visual results are confirmed by weight loss analysis of the specimens excised according to Fig. 2. Table 2 summarizes the mass loss per unit area for the corrosion coupons of each zone investigated together with the exfoliation corrosion rating as prescribed by the ASTM standard. In addition, corrosion potential values for selected samples are presented. The mass loss data are consistent with the ASTM exfoliation corrosion ratings. The lower corrosion potentials in the TMAZ support these observations as well.
