METAL DUSTING OF INLET TUBE MADE OF ALLOY 800

IVAN HRIVŇÁK^{1*}, LUBOMÍR ČAPLOVIČ¹, GEJZA BAKAY²,
AUREL BITTER²

²*DUSLO, a.s., R&D, Šaľa, Slovak Republic*

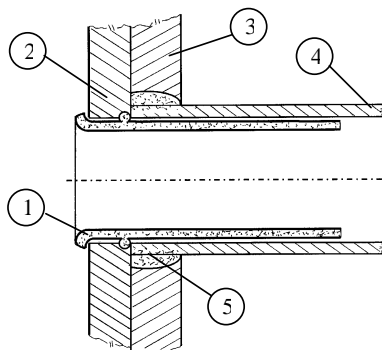
Fig. 1. The set-up of inlet tube (1) in fireclay (2) and tube-sheet (3), (4) – tube made of STN 15 020 steel, (5) – weld.
