Damage mechanism of AZ61-F Mg alloy with nano- Al_2O_3 particles

Key words: AZ61-F Mg- Al_2O_3 , in-situ tensile test in SEM, model of fracture mechanism

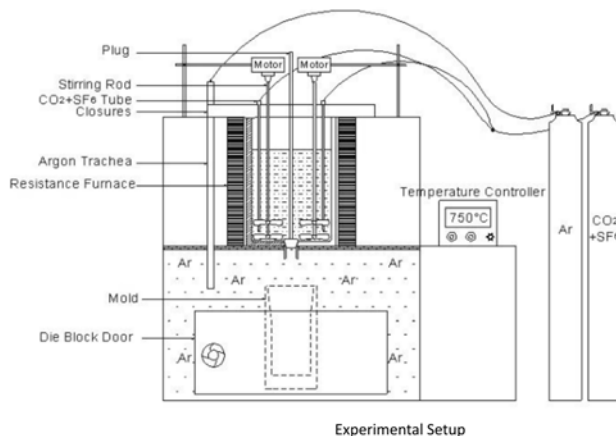
Fig. 1. The melt-stirring scheme used to fabricate the Mg MMCs.

The melt-stirring technique was used to fabricate the present Mg MMC. The AZ61-F and Al_2O_3 particles were initially placed inside a graphite crucible and heated to 400°C in a resistance-heated furnace, Fig. 1; then a stirring vane functioned; meanwhile, CO_2 and SF_6 gushed from gas tank into the crucible to help the mixture of melt. CO_2 and SF_6 also can prevent the melt from oxidation. The crucible was continuously heated up to 700°C , and then the molten alloy was stirred with a vane operated at 350 rev min^{-1} for 3 min. Finally, the composite melt was poured into a metallic mould. The Mg MMC containing 1 wt.% of Al_2O_3 was prepared for further mechanical testing.

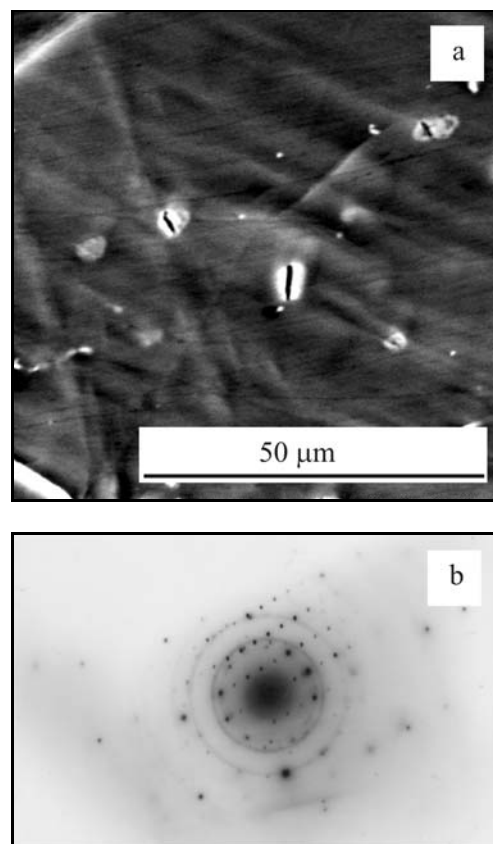
Fig. 2. Fracturing (a) and diffractogram (b) of $\text{Mg}_{17}\text{Al}_{12}$ particles.

Microstructure of the experimental materials is heterogeneous with grain size of $50 \mu\text{m}$. According to works [17, 18] the heat deformation process of the systems, beside formation of incorporated Al_2O_3 phase, leads also to creation of intermetallic compound $\text{Mg}_{17}\text{Al}_{12}$. Deformation is realised through slip systems, which mutually interact by forming microcracks. On Fig. 2a also fracturing $\text{Mg}_{17}\text{Al}_{12}$ particles are visible. They can be the source of cracks in the material microstructure.

Transmission electron microscopy and selective electron diffraction showed presence of $\text{Mg}_{17}\text{Al}_{12}$ phase in the microstructure. This phase has a body centered cubic structure with the lattice parameter $a = 10.569 \text{ \AA}$, Fig. 2b. It has spherical morphology; grain size between $0.2\text{--}0.8 \mu\text{m}$ and it is coherent with

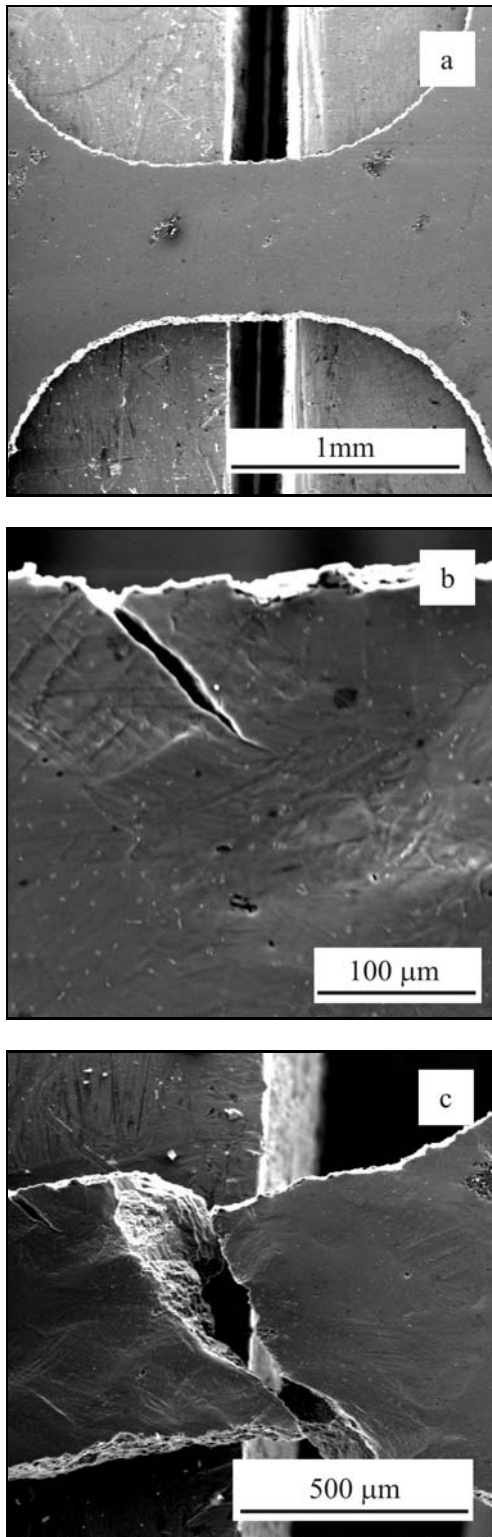
Fig. 3. The specimen before deformation (a), growth of the cracks (b), the final shape of fracture (c).

The samples of experimental materials, Fig. 3a,

were deformed at 20°C at a rate of $6.6 \times 10^{-4} \text{ s}^{-1}$ in elastic region. Because the materials had low plasticity due to the high volume fraction $\text{Mg}_{17}\text{Al}_{12}$ and Al_2O_3 phases, the damage and cracking of test piece was very fast. Cracks were initiated on the surface and propagated approximately perpendicularly to the direction of the tensile load. Overall growth of the cracks is illustrated in Fig. 3b which shows the specimen surface initiation of cavities at the matrix-particle interphase boundaries. Coalescence of the final fracture progressed along densely populated rows parallel to the load direction. The fracture surface formed by the crack growth was inclined by 45° with respect to the specimen principal axis, Fig. 3c.

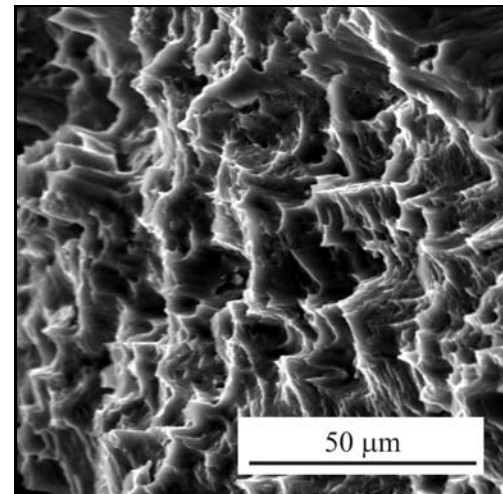
Fig. 4. Final fracture surface.

On the fracture surface, the strengthening Al_2O_3 particles were observed (data not shown). The particles were distributed irregularly, individually or in clusters. During deformation, decohesion between matrix and Al_2O_3 particles takes place that is reflected in the ductile fracture with dimples. Overall, the fracture has transcrystalline ductile character, Fig. 4.
