Fracture mechanisms of Glidcop Cu-Al₂O₃ composite before and after ECAP observed by "in-situ tensile test in SEM"

Abstract

The purpose of this paper is to study the fracture mechanism in the Glidcop AL-60 grade system before and after ECAP (micro- and macro-scale) and to propose damage models.

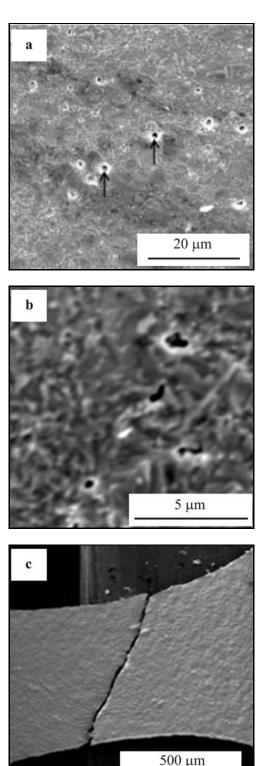
Fig. 1a,b,c. Glidcop before ECAP.

Microstructure of the experimental material contains, besides the Al₂O₃ dispersoid secondary phase, also a low volume fraction, approx. 0.5 vol.%, of closed sharp edged pores (Fig. 1a). Size of Al₂O₃ particles is less than 10 nm, the particles have a globular shape and occur separately and also in clusters. Clusters of particles are randomly distributed in the matrix. The size of pores is significantly higher than the particles, approximately 1–3 μ m. The approximate size of matrix grains was ~ 5 μ m.

The experimental material was deformed at 20 °C at a strain rate of $6.6 \times 10^{-4} \text{ s}^{-1}$ in the elastic region. During deformation of samples the first cracks were created on particle clusters and then on pores inside the sample. Further deformation of samples causes the propagation of crack due to internal effect of the particle clusters (decohesion of small clusters of spheroid Al₂O₃ particles with size < 100 nm) and pores, Fig. 1b.

Initiation and crack propagation before ECAP is in the plane of maximum shear stresses, i.e., ca 45° angle to the direction of tensile loading, Fig. 1c. Macroscopic deformation is too small. Resulting fracture is transcrystalline ductile with dimples with size $< 1 \ \mu m$. The dimples have a regular Poisson-type distribution,

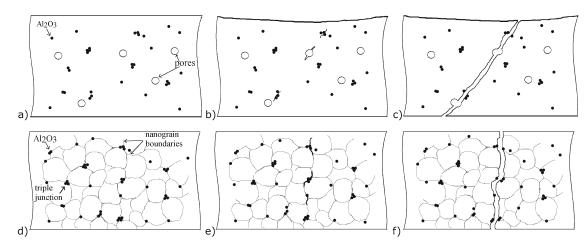
Fig 6. Model of the fracture mechanism before ECAP (a, b, c) and after ECAP (d, e, f).

Based on the microstructure changes observed in the process of deformation, the following model of fracture mechanism before ECAP is proposed, Fig. 6a,b,c:

a) the microstructure in the initial state is characterized by Al_2O_3 particles, their clusters and pores in matrix;

b) with increasing tensile load local cracks on pores occur, there are cracks formed by decohesion of Al_2O_3 particles and clusters;

c) with further increase of deformation of the material crack propagates preferentially along the pores and decohesed particles and clusters in a 45° angle.

The following fracture mechanism of the ECAPed material was proposed, Fig. 6d,e,f:

a) initiation of fracture is caused by cracks in triple junctions as well as by decohesion of Al_2O_3 particles and clusters in the middle of the specimen;

b) fracture is propagated very quickly at minimum plastic deformation;

c) fracture is perpendicular to the tensile loading of the specimen.
